Inspection Report Minerals Regulatory Program

July 10, 2006

Mine Name: Timberline Permit number: M490053
Operator Name: DJN Rockwalls Inspection Date: June 27, 2006
Time: 11:30 am to 1:00 pm

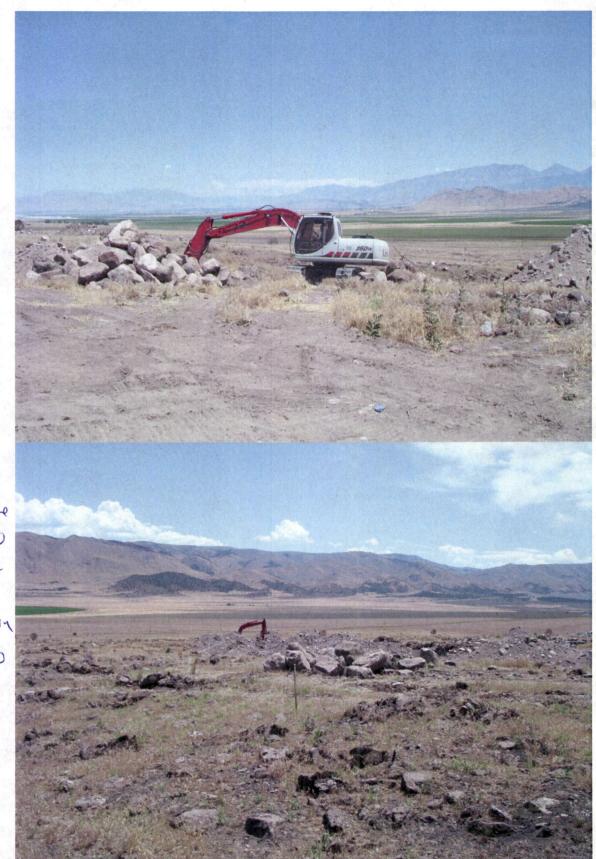
operating within the 5 acre 5mo boundary note Stake in Center of photo.

The leaking fuel tank needs to be cleaned up. We need to investigate this situation further to determine who the tank belongs to and who is responsible for cleaning it up. Need to continue to monitor the location of the excavation to ensure that it does not expand beyond the area covered in the NOI-SMO.

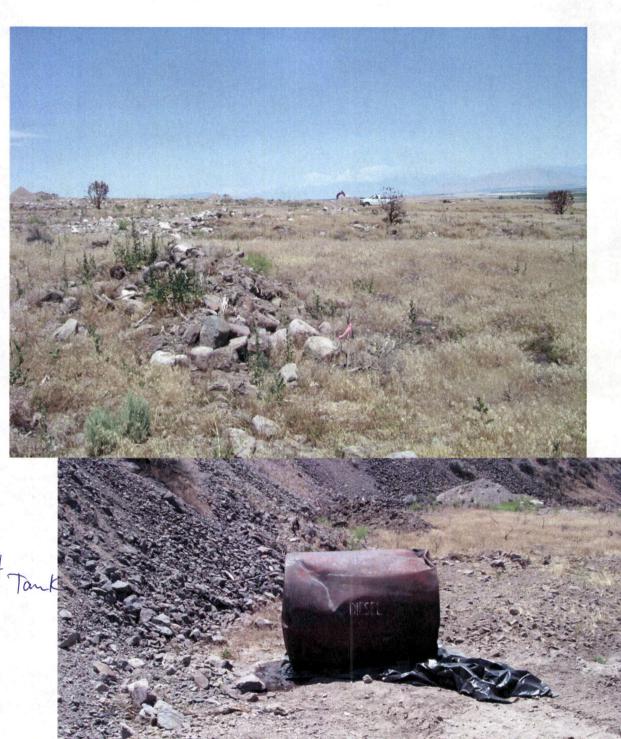
I also questioned him about the leaking fuel tank adjacent to the property. He indicated that it did not belong to DJN and he thought it belonged to the adjacent operator. It appeared that there had been some attempt to clean up the tank (someone had placed a sheet of black plastic beneath it) however, it was still there and still leaking.

Leating Ful Tank
